# Weekly Construction Report

## Hatchery Creek Design/Build Project

<b>Time Period:</b>	October 26-31, 2015	<b>Project No:</b>	1305
<b>Rain Days/Weather Conditions:</b>	Rain 1.2" from Monday, Oct. 26 <sup>th</sup> through Wednesday, Oct. 28 <sup>th</sup> (Burkesville gauge). We did not work Tuesday through Thursday.		
<b>Personnel on-site:</b>	<i>EcoGro/Ridgewater:</i> Tom Cutter, Eric Dawalt, Jim Hanssen, Larry Mounce, Brad Redmon, Chad Relinski, Randall "Mokie" Starns, Randall Starns, Jr., Sherri Arthur Trucking-John Arthur.		
<b>Equipment on-site:</b>	Komatsu PC 360 excavator w/ hyd. thumb, Komatsu PC 160 w/ hyd. thumb, Komatsu PC 210 excavator, Komatsu PC 240 excavator, Terex TA27 articulated off-road dump truck, Bobcat T300 skid steer, & Morooka 2200 track dump truck.		
<b>Material deliveries to project site:</b>	<ul style="list-style-type: none"> <li>115 tons of spawning gravel (1,660 tons to date).</li> </ul>		
<b>Work performed the past week:</b>	<ul style="list-style-type: none"> <li>Site #2 and #3: <ul style="list-style-type: none"> <li>Cleaned up wood and rock stockpile areas along River Road and regraded haul roads.</li> <li>Installed boulder stepping stones across bo

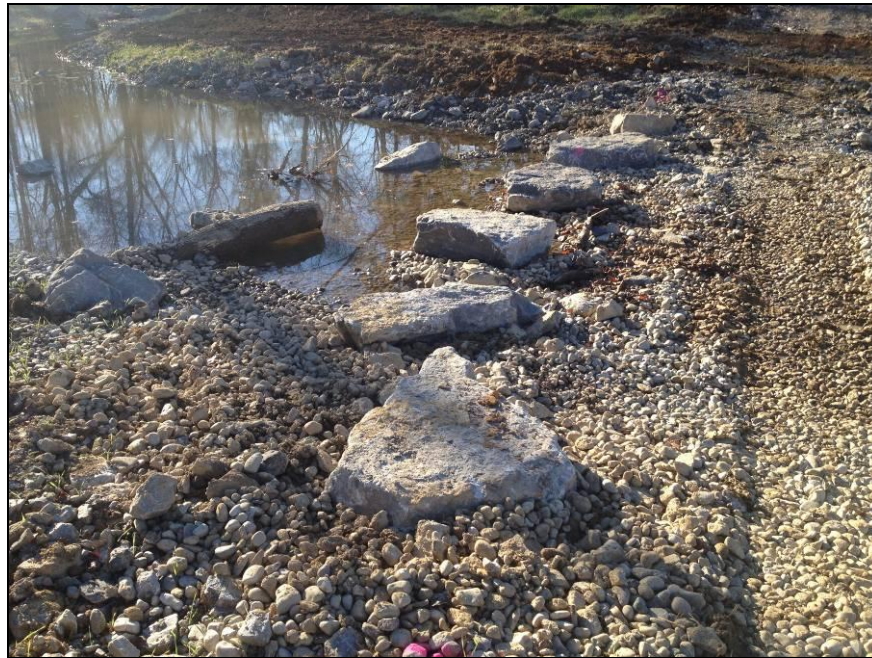
**Site #2: Boulders installed for pedestrian stepping stones across stream at low water crossing at ~Sta. 143+40. (Picture taken on Right Descending Bank (RDB) looking across channel).**

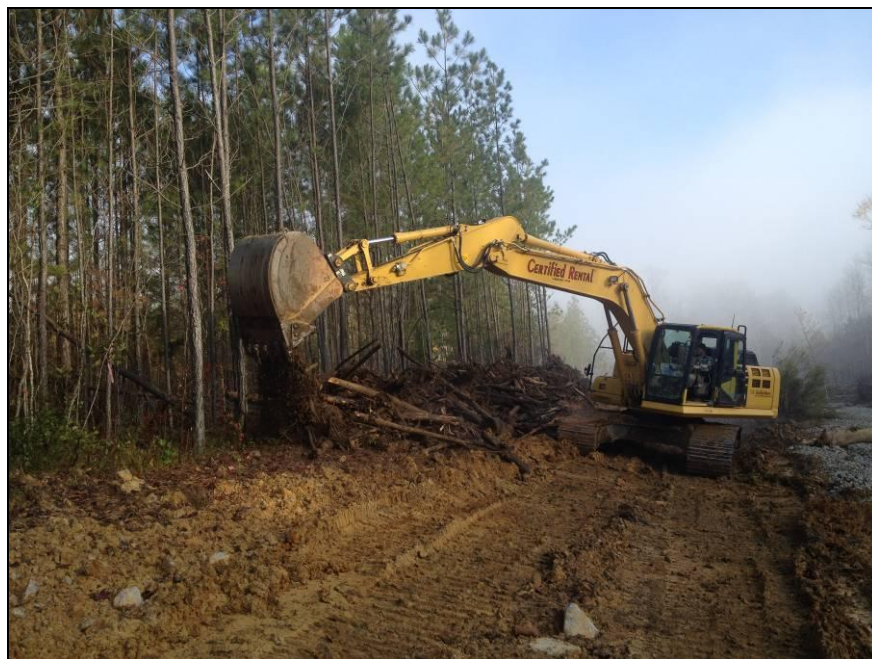
**Site #1: Spreading stockpiled topsoil and wood along stream channel to increase carbon and organic matter in soil. (Picture from LDB at ~Sta. 119+00 looking downstream).**

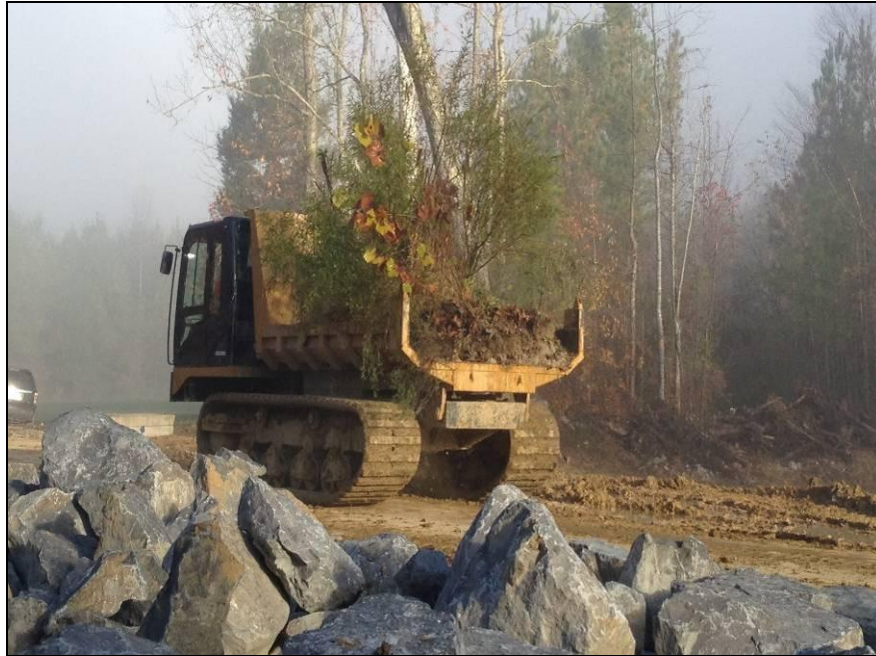
**Site #1: Hauling in willows and sycamores harvested on-site. (Picture taken at Campground Road at ~Sta. 117+50).**

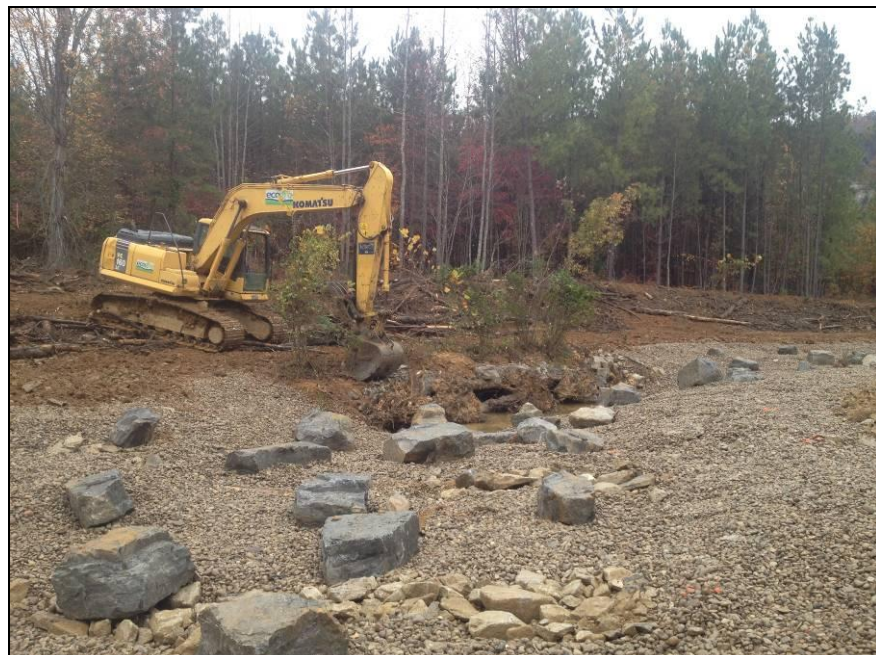
**Site #1: Transplanting willows and sycamores along stream that were harvested on-site. (Picture taken at ~Sta. 121+70 looking downstream).**

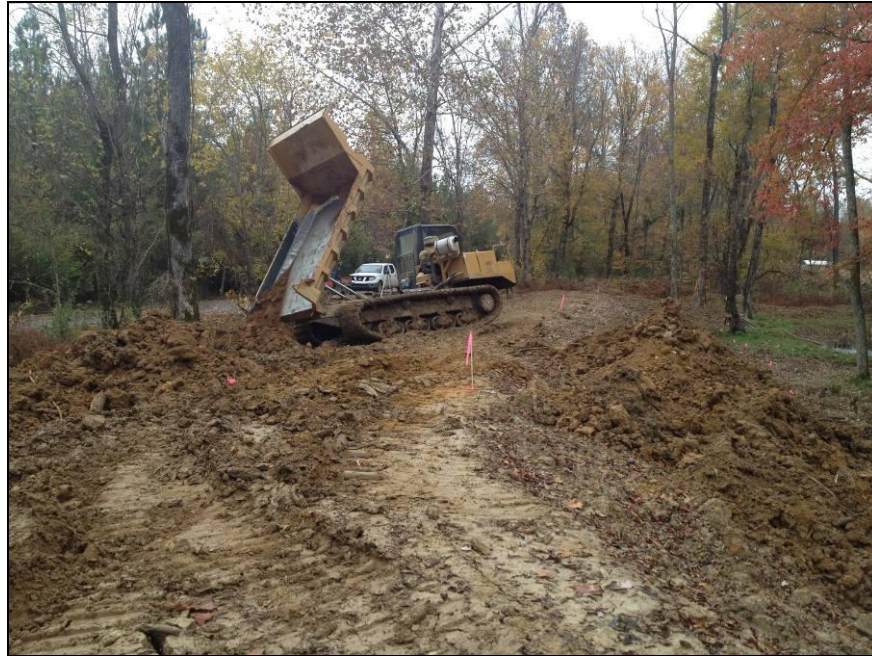
***Reach downstream of migration barrier: Building floodplain berm adjacent to braided channel reach. (Picture taken from ~ LT Sta. 112+50 looking downstream).***

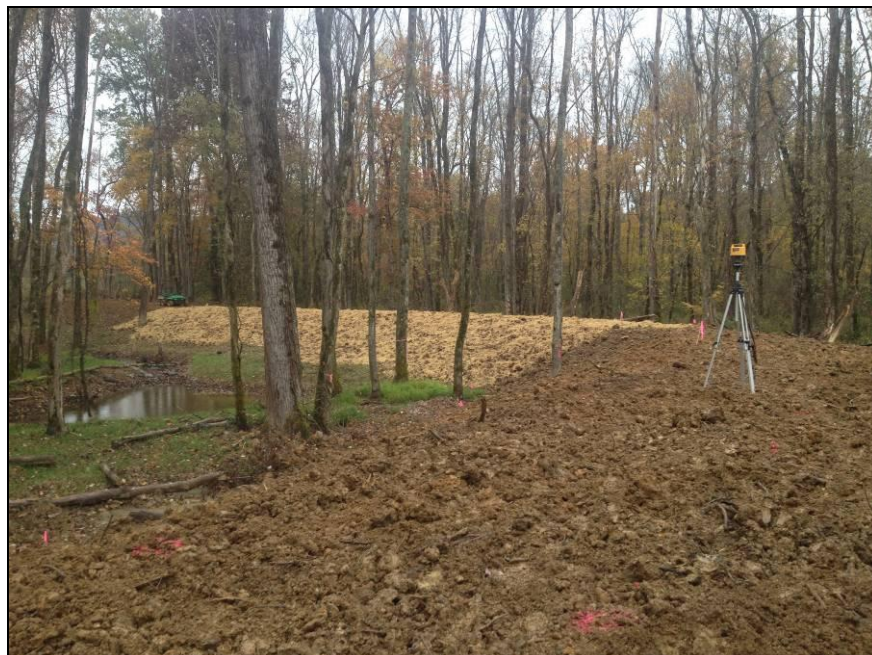
***Reach downstream of migration barrier: Completed floodplain berm adjacent to braided channel reach. (Picture taken from ~ LT Sta. 112+50 looking upstream).***

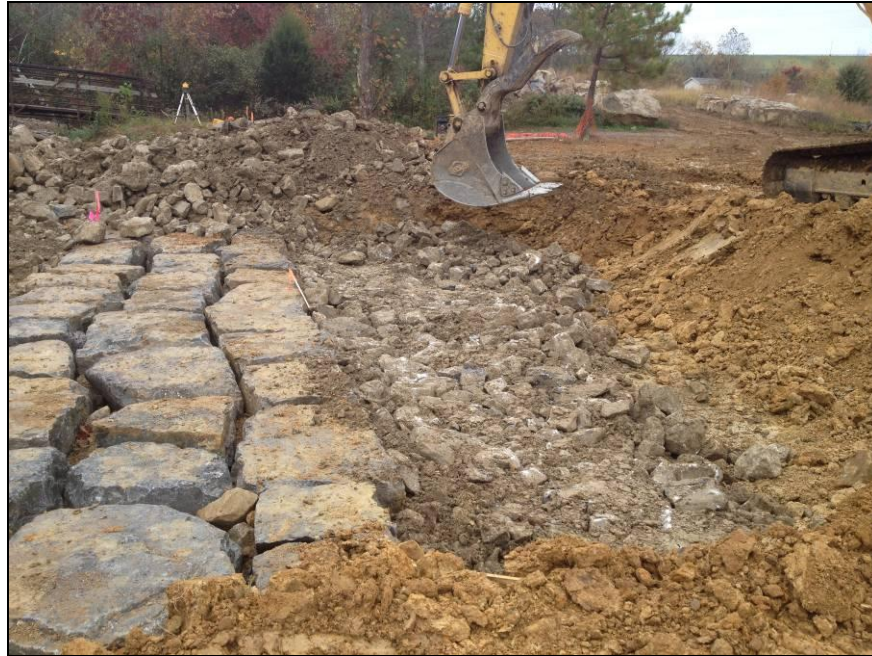
**Migration Barrier: Installing shot rock base for boulder step. Splash pad rocks can be seen in left of picture. (Picture taken from LDB at ~Sta. 105+90 looking across channel).**

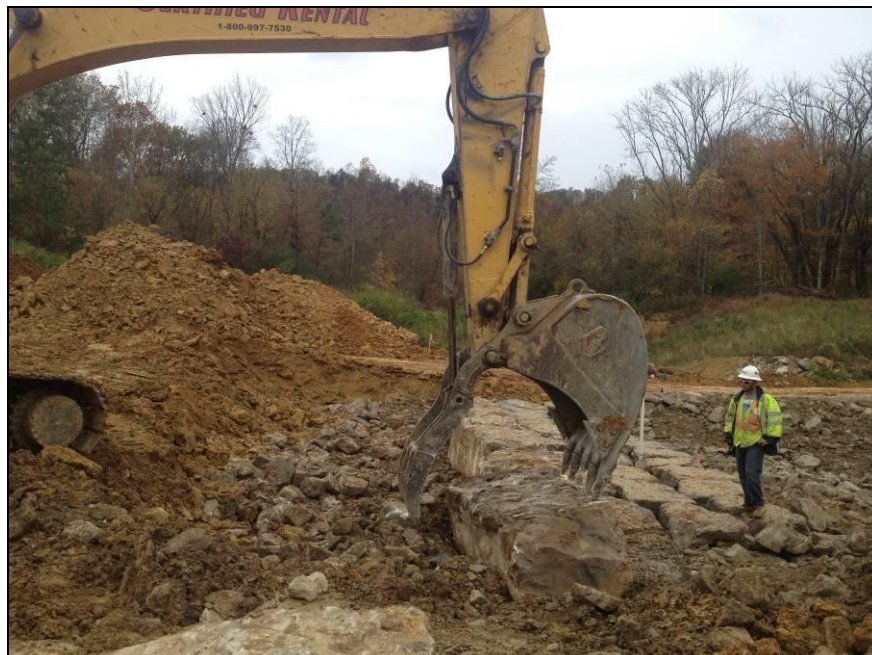
**Migration Barrier: Installing boulders for step. (Picture taken from RDB at ~Sta. 105+90 looking across channel).**

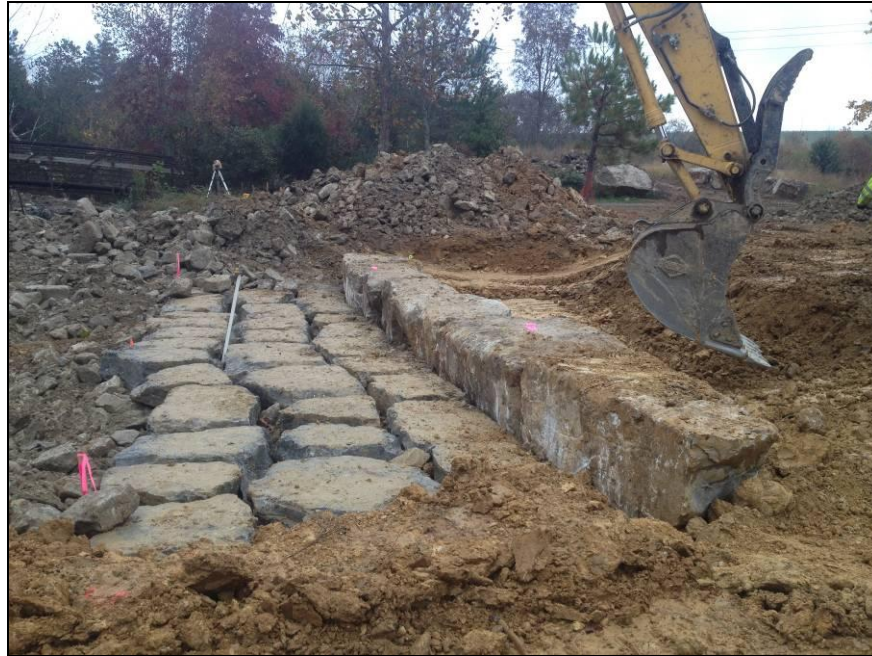
***Migration Barrier: Boulder step installed with 24" drop to splash pad. (Picture taken from LDB at ~Sta. 105+90 looking across channel.***

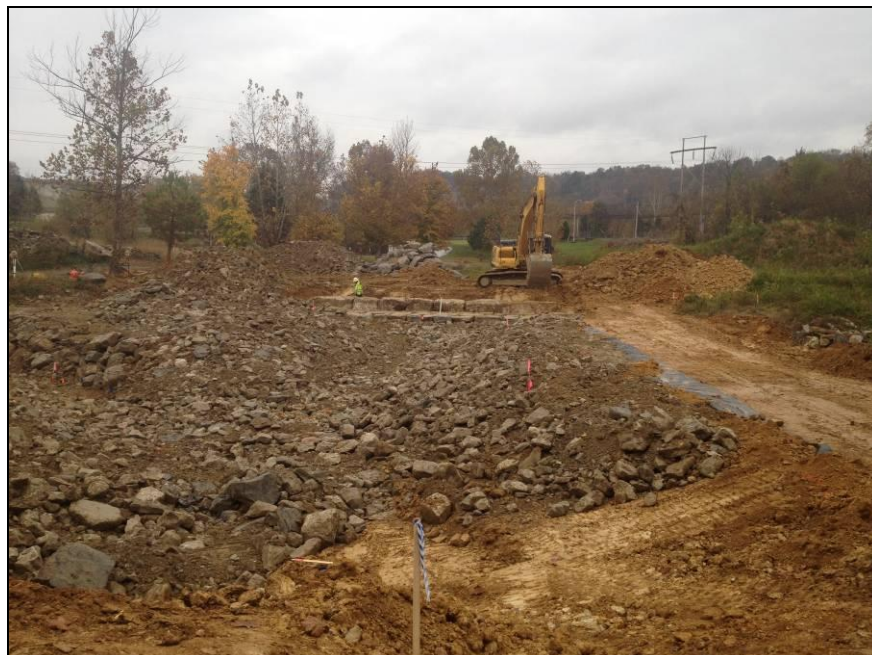
***Migration Barrier: Boulder step installed with 24" drop to splash pad. (Picture taken from ~Sta. 107+00 looking upstream).***
